## Wildland Urban Interface Area Inventory Assessment

Chris Gober, Bernalillo County Fire Department  
Frank Barka, Bernalillo County Fire Department  
Karen Lightfoot, New Mexico State Forestry  
July 2002

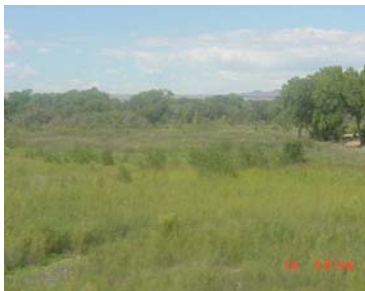
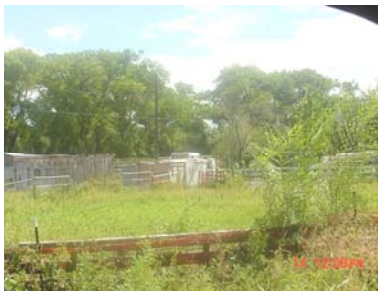
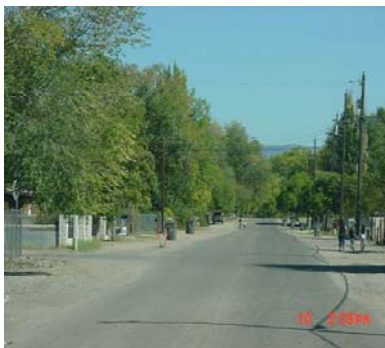
**Vegetation Fuels:** The fuels in this area are typical of the Rio Grande Bosque, which consists of cottonwood, salt cedar, Russian olive, swamp grasses.

**Construction Materials:** Construction materials in this area vary from adobe brick to wood frame.

**Roof:** Roofing material in the subdivision varies from wood shake to metal.

**Decks:** A majority of the homes in this area have unprotected wood decks.

**Special Hazards:** Above Ground electrical lines, propane tanks, narrow winding roads.

**Average Hazard Rating: High** (access, high density, no defensible space, water availability, fire history)

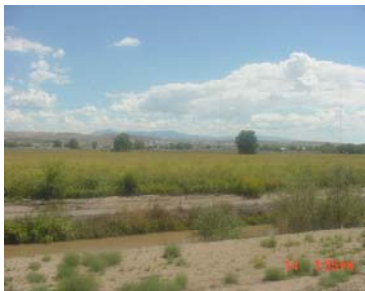
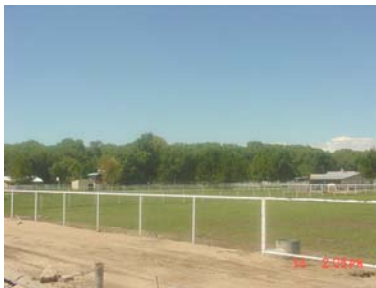
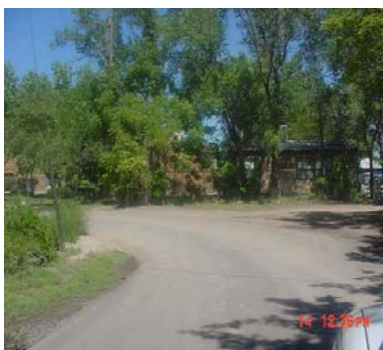
**Vegetation Fuels:** The fuels in this area are typical of the Rio Grande Bosque, which consists of cottonwood, salt cedar, Russian olive, swamp grasses.

**Construction Materials:** Construction materials in this area vary from adobe brick to wood frame.

**Roof:** Roofing material in the subdivision varies from wood shake to metal.

**Decks:** A majority of the homes in this area have unprotected wood decks.

**Special Hazards:** Above Ground electrical lines, propane tanks, narrow winding roads.

**Average Hazard Rating: Moderate** (access, high density, no defensible space, water availability, fire history)

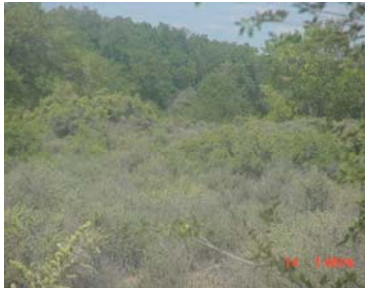
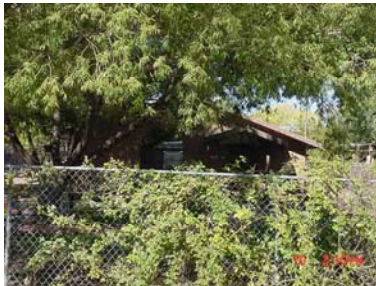
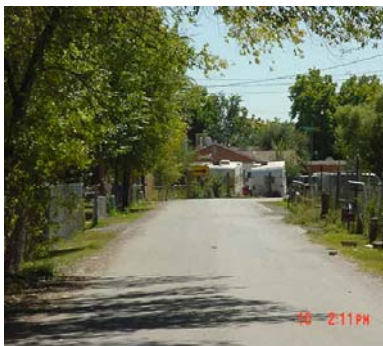
**Vegetation Fuels:** The fuels in this area are typical of the Rio Grande Bosque, which consists of cottonwood, salt cedar, Russian olive, swamp grasses.

**Construction Materials:** Construction materials in this area vary from adobe brick to wood frame.

**Roof:** Roofing material in the subdivision varies from wood shake to metal.

**Decks:** A majority of the homes in this area have unprotected wood decks.

**Special Hazards:** Above Ground electrical lines, propane tanks, narrow winding roads.

**Average Hazard Rating:** High, (access, high density, no defensible space, water availability, fire history)

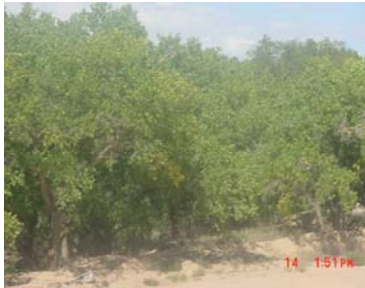
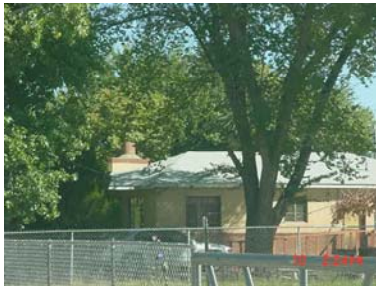
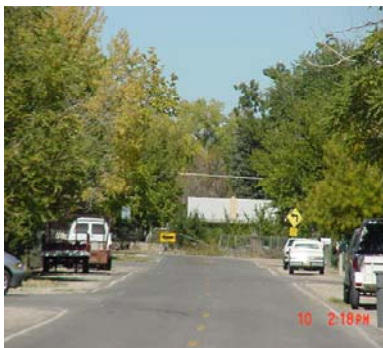
**Vegetation Fuels:** The fuels in this area are typical of the Rio Grande Basque, which consists of cottonwood, salt cedar, Russian olive, swamp grasses.

**Construction Materials:** Construction materials in this area vary from adobe brick to wood frame.

**Roof:** Roofing material in the subdivision varies from wood shake to metal.

**Decks:** A majority of the homes in this area have unprotected wood decks.

**Special Hazards:** Above Ground electrical lines, propane tanks, narrow winding roads. No defensible space between buildings and Wildland fuels.

**Average Hazard Rating: Moderate** (access, high density, no defensible space, water availability, fire history)

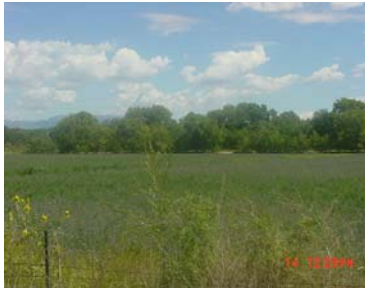
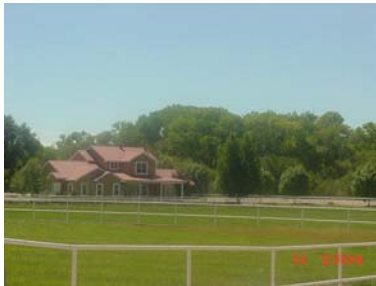
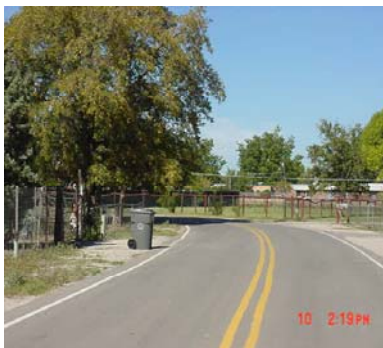
**Vegetation Fuels:** The fuels in this area are typical of the Rio Grande Bosque, which consists of cottonwood, salt cedar, Russian olive, swamp grasses.

**Construction Materials:** Construction materials in this area vary from adobe brick to wood frame.

**Roof:** Roofing material in the subdivision varies from wood shake to metal.

**Decks:** A majority of the homes in this area have unprotected wood decks.

**Special Hazards:** Above Ground electrical lines, propane tanks, narrow winding roads. No defensible space between buildings and Wildland fuels.

**Average Hazard Rating: Moderate** (access, high density, no defensible space, water availability, fire history)

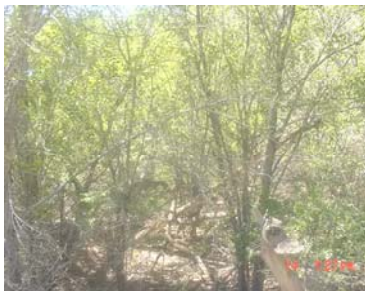
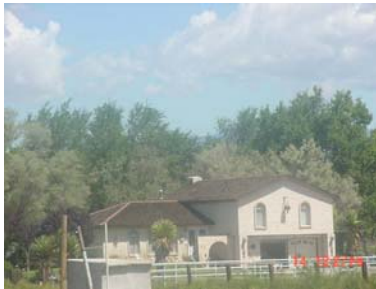
**Vegetation Fuels:** The fuels in this area are typical of the Rio Grande Bosque, which consists of cottonwood, salt cedar, Russian olive, swamp grasses.

**Construction Materials:** Construction materials in this area vary from adobe brick to wood frame.

**Roof:** Roofing material in the subdivision varies from wood shake to metal.

**Special Hazards:** Above Ground electrical lines, propane tanks, narrow winding roads.

**Average Hazard Rating: High** (access, high density, no defensible space, water availability, fire history)

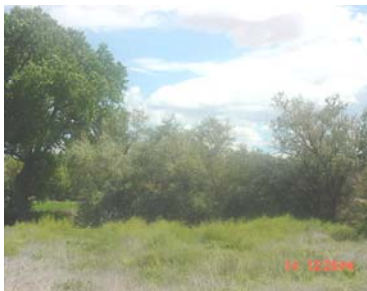
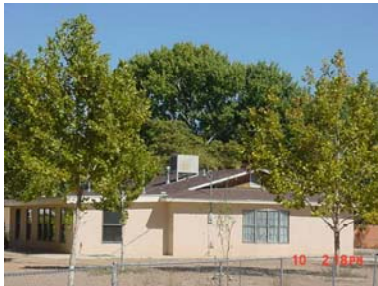
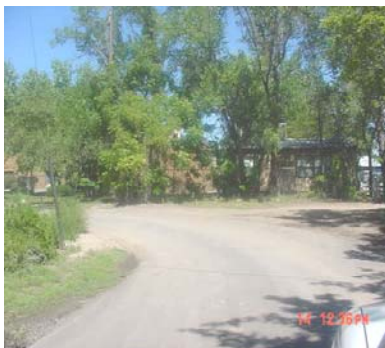
**Descriptive Location:** This area is located South 2<sup>nd</sup> Street in the South Valley of Bernalillo County. This area runs along the East side of the Rio Grande River.

**Vegetation Fuels:** The fuels in this area are typical of the Rio Grande Bosque, which consists of cottonwood, salt cedar, Russian olive, and swamp grasses.

**Construction Materials:** Construction materials in this area vary from adobe brick to wood frame.

**Roof:** Roofing material in the subdivision varies from wood shake to metal.

**Decks:** A majority of the homes in this area have unprotected wood decks.

**Special Hazards:** Above Ground electrical lines, propane tanks, narrow winding roads. Water treatment plant with hazardous materials storage.

**Average Hazard Rating: Moderate** (access, high density, no defensible space, water availability, fire history)

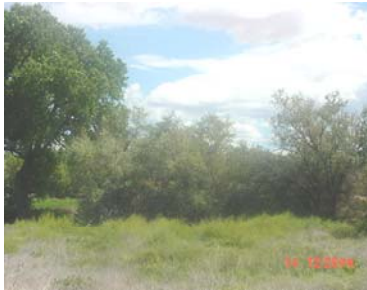
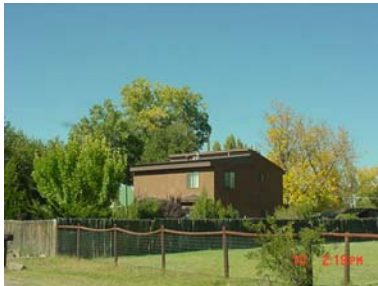
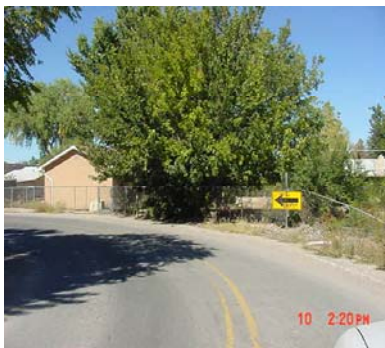
**Descriptive Location:** This area is located off of south Isleta Blvd in the South Valley of Bernalillo County. This area runs along the West Side of the Rio Grande River.

**Vegetation Fuels:** The fuels in this area are typical of the Rio Grande Bosque, which consists of cottonwood, salt cedar, Russian olive, swamp grasses.

**Roof:** Roofing material in the subdivision varies from wood shake to metal.

**Decks:** A majority of the homes in this area have unprotected wood decks.

**Access:** The main access to this area is off of south Isleta Blvd., which is a two-lane paved road. There is limited to no access to the Bosque from this area.

**Special Hazards:** Above Ground electrical lines, propane tanks, narrow winding roads.

**Average Hazard Rating: Moderate** (access, high density, no defensible space, water availability, fire history)

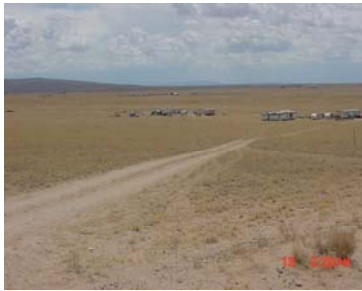
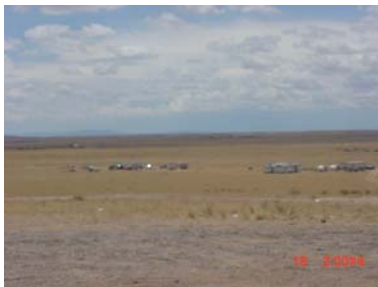
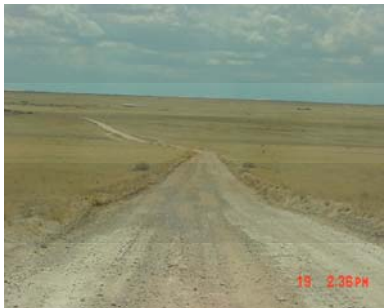
**Descriptive Location:** This area is located at the west end of Pajarito Road from Paseo Del Volcano to the Isleta Indian Reservation (North to South) and Coors to Laguna Indian Reservation (East to West). This area is not developed and most of the residents are homesteading.

**Vegetation Fuels:** The fuels in this area are grass and sagebrush

**Construction Materials:** Most of the homes in this area are older model mobile homes, or poorly built wood frame.

**Roof:** Roofing material in this area varies from metal to wood decking.

**Siding:** Homes in this area either have metal siding or plywood siding.

**Decks:** A majority of the homes in this area had unprotected wood decks.

**Access:** This area is located at the West End of Pajarito Road. There are multiple ways in and out of this area, although none of the roads are marked or maintained.

**Special Hazards:** high voltage power lines, terrain, building construction no defensible space

**Average Hazard Rating:** Extreme (access, rapid growth, no defensible space, water availability, fire history)

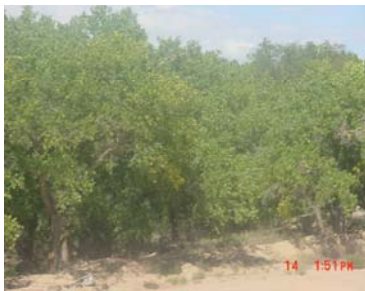
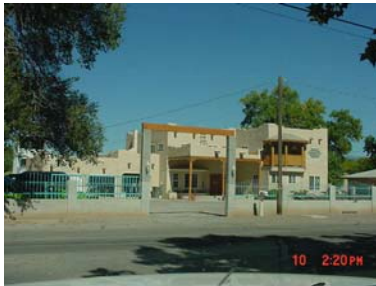
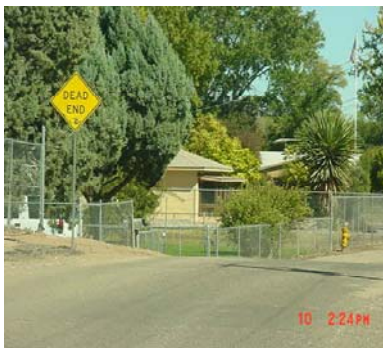
**Descriptive Location:** This area is along 2<sup>nd</sup> Street between Woodward Rd and Rio Bravo Blvd. This area runs along the East Side of the Rio Grande River. There are several crop fields in this area that are on the boundary of the Bosque.

**Vegetation Fuels:** The fuels in this area are typical of the Rio Grande Bosque, which consists of cottonwood, salt cedar, Russian olive, swamp grasses.

**Roof:** Roofing material in the subdivision varies from wood shake to metal.

**Decks:** A majority of the homes in this area have unprotected wood decks.

**Access:** The main access to this area is off of 2<sup>nd</sup> Street, which is a two-lane paved road. There is limited access to the Bosque from this area

**Special Hazards:** Above Ground electrical lines, propane tanks, narrow winding roads. No defensible space between buildings and Wildland fuels.

**Average Hazard Rating: Moderate** (access, high density, no defensible space, water availability, fire history)

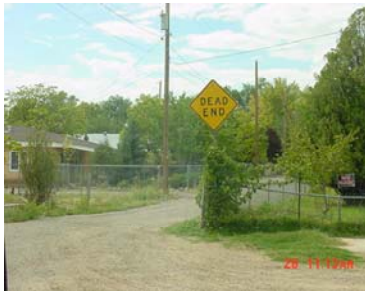
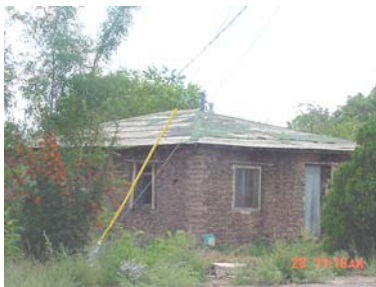
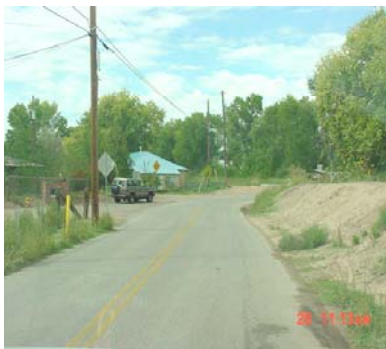
**Descriptive Location:** This area is located off of Alameda Blvd in the North Valley of Bernalillo County. This area runs along the East bank of the Rio Grande River. There are large homes, and large agricultural fields in this area. Alameda Blvd. In one of the main access roads to Rio Rancho and the Westside of Albuquerque.

**Vegetation Fuels:** The fuels in this area are typical of the Rio Grande Bosque, which consists of cottonwood, salt cedar, Russian olive, swamp grasses, and agricultural fields.

**Roof:** Roofing material in the subdivision varies from wood shake to metal. (Mostly asphalt shingles)

**Decks:** A majority of the homes in this area have unprotected wood decks.

**Access:** The main access to this area is off of Alameda Blvd. (which is a four-lane paved road); there is limited access to the Bosque from this area

**Special Hazards:** Above Ground electrical lines, narrow winding roads.

**Average Hazard Rating:** Moderate (access, no defensible space, water availability, fire history)

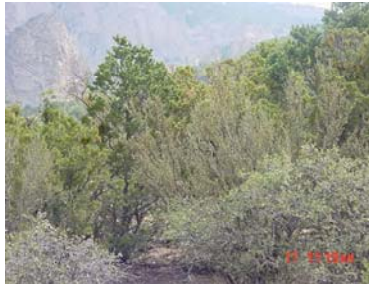
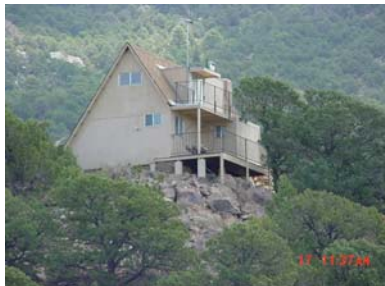
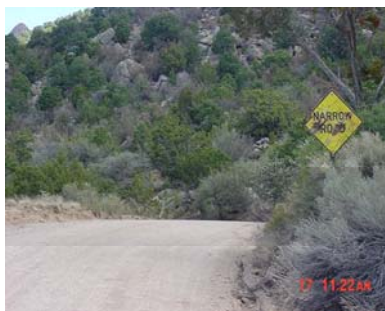
**Descriptive Location:** This subdivision is in Juan Tabo Canyon in Sandoval and Bernalillo Counties, at the end of SR 333. The subdivision is surrounded by U.S Forest Service land. Evergreen Hills is in the Sandia Foothills on the west aspect of the Sandia Mountains.

**Vegetation Fuels:** The fuels in this area are typical for the Foothills of the Sandia Mountains. Which consists of pinyon juniper, sagebrush, and patchy grass.

**Roof:** Most of the homes have metal roofs, although some of the homes do have asphalt shingles.

**Decks:** Most of the decks are made out of concrete and are ground level, there was one deck noted that is not enclosed

**Access:** Subdivision is located behind a locked gate at the end of SR 333, which is the only way in and out of the subdivision. This road also services another subdivision, and U.S. Forest recreation areas.

**Water Availability:** There were no water sources noted that could be used for fire fighting activities; the only water source would be tender shuttle. The closest fill site for a tender would be a fire hydrant at Tramway Rd. and Tramway Blvd, which is 3 driving miles away.

**Special Hazards:** Road washing out, no electrical utilities in the subdivision. No defensible space around homes and propane tanks.

**Average Hazard Rating: High** (access, slope, distance from fire fighting equipment, and water sources, fire history)

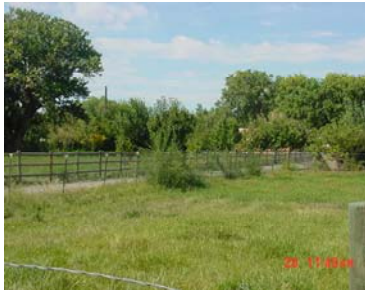
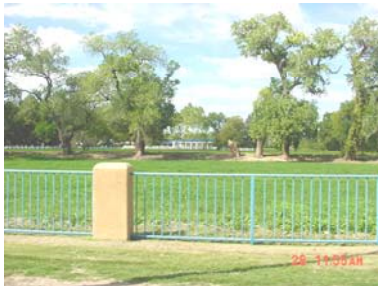
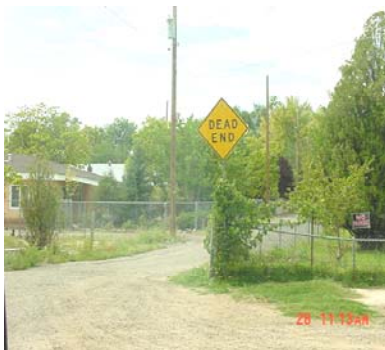
**Descriptive Location:** This area is between 4<sup>th</sup> Street and the Rio Grande River in the City of Albuquerque. This area runs along the East Bank of the Rio Grande River. There are some large homes and agricultural fields in this area.

**Vegetation Fuels:** The fuels in this area are typical of the Rio Grande Bosque, which consists of cottonwood, salt cedar, Russian Olive, swamp grasses, agricultural fields.

**Roof:** Roofing material in the subdivision varies from wood shake to metal. (Mostly asphalt shingles)

**Decks:** A majority of the homes in this area have unprotected wood decks.

**Special Hazards:** Above Ground electrical lines, no defensible space

**Average Hazard Rating: Moderate** (access, high density, no defensible space, water availability, fire history)

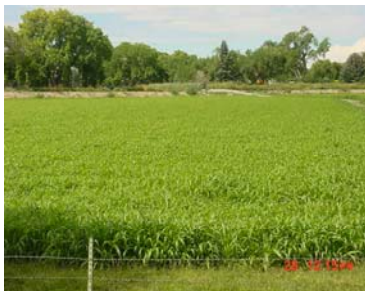
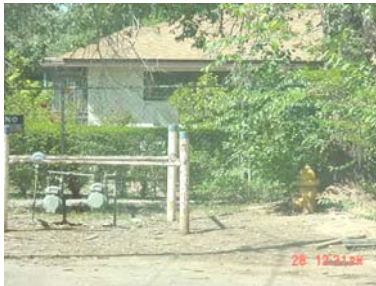
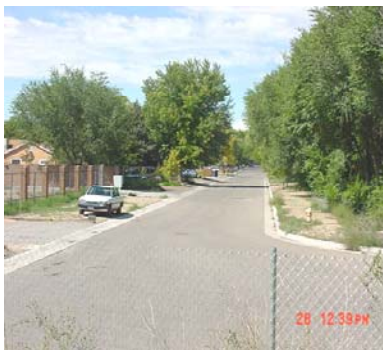
**Descriptive Location:** This area is between 4<sup>th</sup> Street and the Rio Grande River just south of Los Candelarias in the City of Albuquerque. This area runs along the East Bank of the Rio Grande River. There are some large homes and agricultural fields in this area.

**Vegetation Fuels:** The fuels in this area are typical of the Rio Grande Bosque, which consists of cottonwood, salt cedar, Russian Olive, swamp grasses, agricultural fields.

**Roof:** Roofing material in the subdivision varies from wood shake to metal. (Mostly asphalt shingles)

**Decks:** A majority of the homes in this area have unprotected wood decks.

**Special Hazards:** Above Ground electrical lines, no defensible space

**Average Hazard Rating:** **Moderate** (access, high density, no defensible space, water availability, fire history)

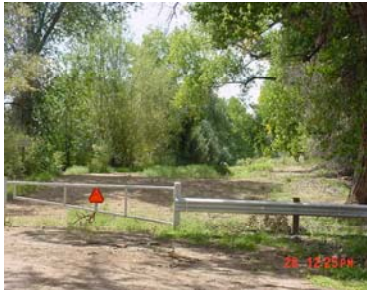
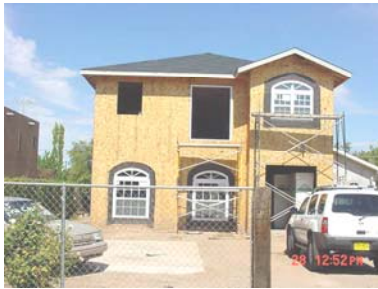
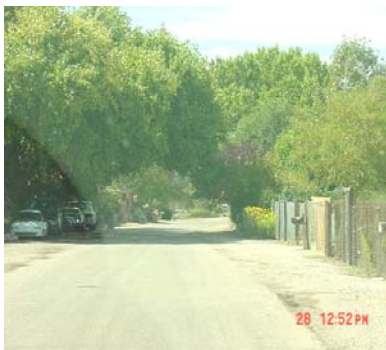
**Descriptive Location:** This area is off of Griegos Rd Between 4<sup>th</sup> Street and the Rio Grande River in the City of Albuquerque. This area runs along the East bank of the Rio Grande River.

**Vegetation Fuels:** The fuels in this area are typical of the Rio Grande Bosque, which consists of cottonwood, salt cedar, Russian olive, swamp grasses,

**Roof:** Roofing material in the subdivision varies from wood shake to metal. (Mostly asphalt shingles)

**Decks:** A majority of the homes in this area have unprotected wood decks.

**Special Hazards:** Above Ground electrical line, no defensible space

**Average Hazard Rating: Moderate** (access, high density, no defensible space, water availability, fire history)

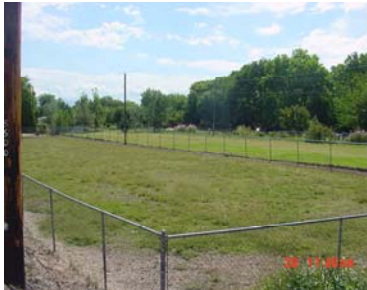
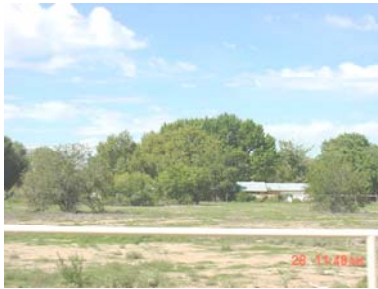
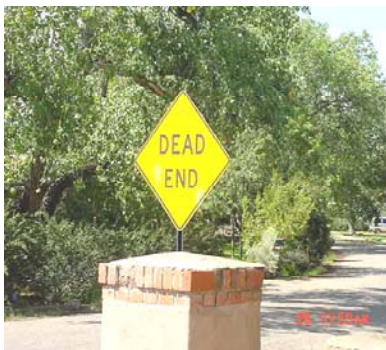
**Descriptive Location:** This area is the North Valley of Bernalillo County and runs along the East bank of the Rio Grande River. There are large homes with a high dollar value, and agricultural fields.

**Vegetation Fuels:** The fuels in this area are typical of the Rio Grande Bosque, which consists of cottonwood, salt cedar, Russian Olive, swamp grasses, agricultural fields.

**Roof:** Roofing material in the subdivision varies from wood shake to metal. (Mostly asphalt shingles)

**Decks:** A majority of the homes in this area have unprotected wood decks.

**Special Hazards:** Above Ground electrical lines, high voltage distribution electrical lines, no defensible space

**Average Hazard Rating:** **Moderate** (access, high density, no defensible space, water availability, fire history)

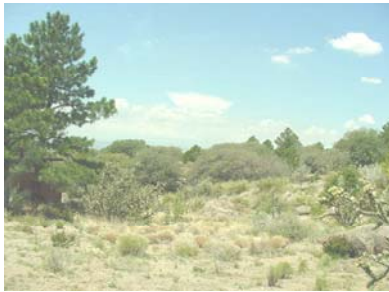
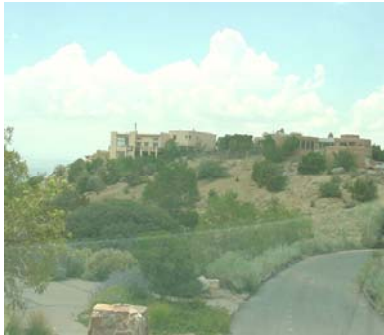
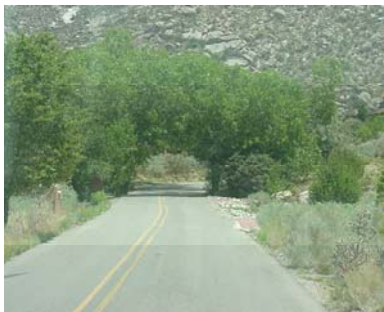
**Descriptive Location:** This subdivision is in La Cueva Canyon in Bernalillo County. U.S. Forest Service and Sandia Indian reservation land surround the subdivision. North Sandia Heights is in the Sandia Foothills on the west aspect of the Sandia Mountains.

**Vegetation Fuels:** The fuels in this area are typical for the Foothills of the Sandia Mountains. Which consists of Pinyon-Juniper, sagebrush, and patchy grass.

**Roof:** Roofing material in the subdivision varies from wood shake to metal.

**Decks:** A majority of the homes in this area have unprotected wood decks.

**Access:** This Subdivision is located off of Tramway road, which also services another community, a restaurant, and the Tramway. Tramway Road is the only way out for all of the above.

Bridges: many homes within the subdivision had bridges incapable of carrying the weight of fire apparatus. None were noted on the main access ways

**Special Hazards:** Exposed propane tanks, unprotected wood decks, homes built on ridge tops, in chimneys and chutes one way in and out of subdivision, no defensible space.

**Average Hazard Rating: High** (access, high density, no defensible space, water availability, fire history)

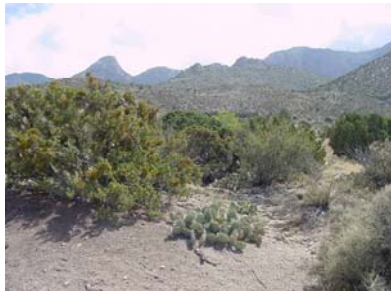
**Descriptive Location:** This subdivision is in Juan Tabo Canyon in Bernalillo County, off of F.R. 333. The subdivision is surrounded by U.S. Forest Service land. Tierra Monte is in the Sandia Foothills on the west aspect of the Sandia Mountains.

**Vegetation Fuels:** The fuels in this area are typical for the Foothills of the Sandia Mountains. Which consists of Pinyon-Juniper, sagebrush, and patchy grass.

Bridges: many homes within the subdivision had bridges incapable of carrying the weight of fire apparatus. None were noted on the main access ways

**Special Hazards:** exposed propane tanks, unprotected wood decks, homes built on ridge tops, in chimneys and chutes one way in and out of subdivision, no defensible space.

**Average Hazard Rating:** High (access, slope, no defensible space, fire history)

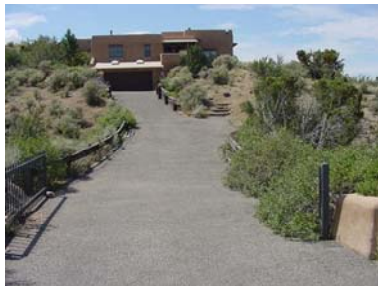
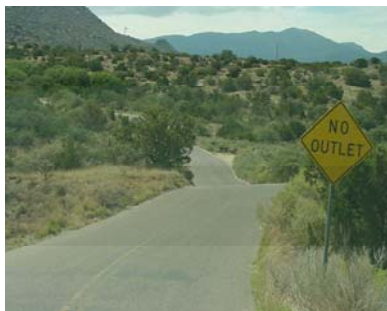
**Construction Materials:** All of the homes in Tierra Monte are wood frame type construction.

**Roof:** Most of the homes have flat roof with asphalt covering, some homes had composite shingles, and tiled roofing material.

**Decks:** A majority of the homes in this area have unprotected wood decks.

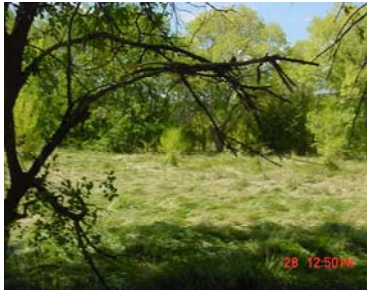
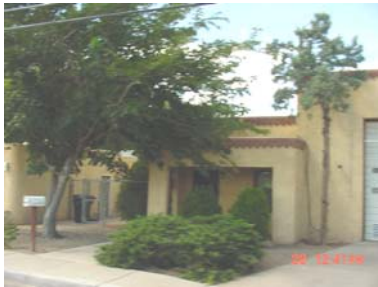
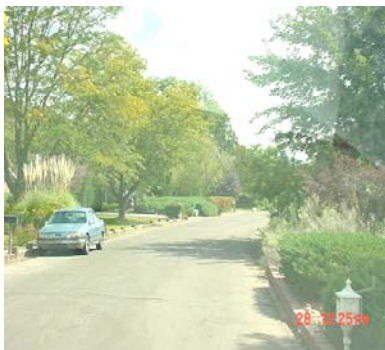
**Vegetation Fuels:** The fuels in this area are typical of the Rio Grande Bosque, which consists of cottonwood, salt cedar, Russian olive, and swamp grasses,  
**Density:** (population/square mile) 2,00  
**Number of Lots:** 3,000  
**Total Acres:** 3,200

**Construction Materials:** Construction materials in this area vary from adobe brick to wood frame. (Mostly wood frame)

**Roof:** Roofing material in the subdivision varies from wood shake to metal. (Mostly asphalt shingles)

**Decks:** A majority of the homes in this area have unprotected wood decks.

**Special Hazards:** Above Ground electrical line, no defensible space, historical areas, zoo, aquarium

**Average Hazard Rating: Moderate** (access, slope, no defensible space, water availability, fire history)

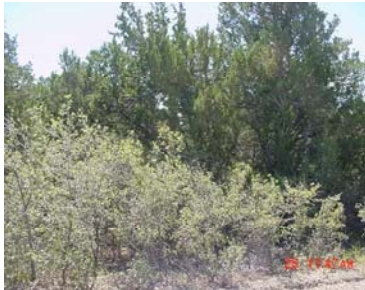
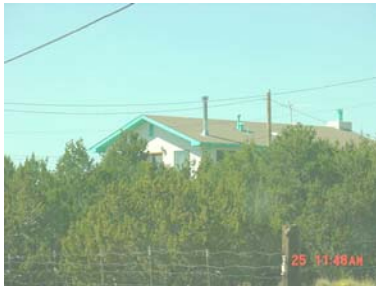
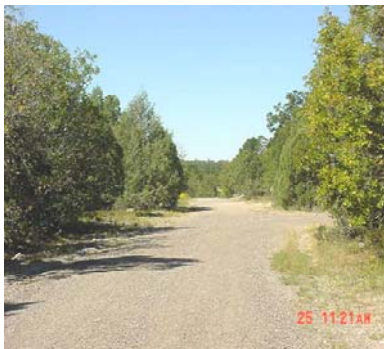
**Vegetation Fuels:** The fuels in this area are typical of the lower elevation, which consist of pinyon-juniper, grasses, sagebrush, and scrub oak. The fuels in this area are drought stricken, diseased, or insect infested.

**Construction Materials:** Wood frame.

**Roof:** mostly asphalt shingles a few with wood shake

**Decks:** A majority of the homes in this area have unprotected wood decks.

**Special Hazards:** Above Ground electrical lines, narrow winding roads. No defensible space, house built mid-slope, at the top of slopes, in chimneys, and in chutes. Long turn around time for water tenders.

**Average Hazard Rating: High** (access, slope, no defensible space, building materials water availability, fire history)

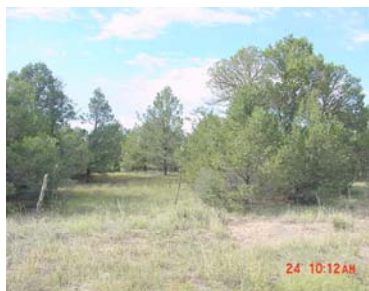
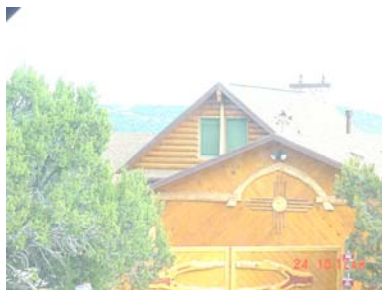
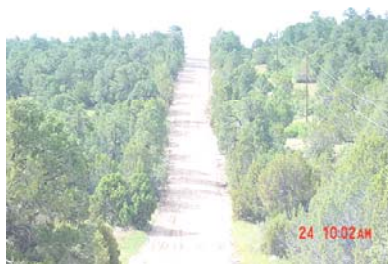
**Vegetation Fuels:** The fuels in this area are typical of the lower elevation conifers, which consist of pinyon-juniper, grasses, sagebrush, and scrub oak. A lot of the fuels in this area are drought stricken, or insect infested, or diseased.

**Construction Materials:** Wood frame type construction

**Roof:** Mostly asphalt shingles a few with wood shake

**Decks:** A majority of the homes in this area have unprotected wood decks.

**Special Hazards:** Above Ground electrical lines, narrow winding roads. No defensible space, house built mid-slope, at the top of slopes, in chimneys, and in chutes.

**Average Hazard Rating: High** (access, slope, no defensible space, building materials, water availability, fire history)

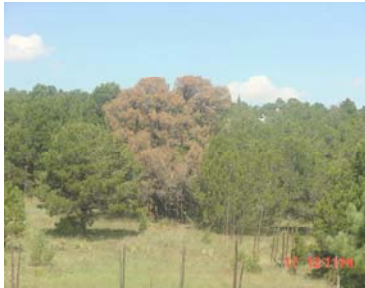
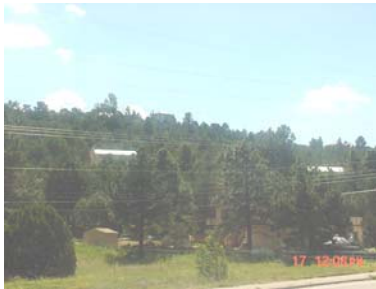
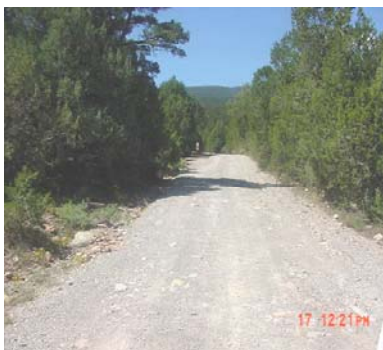
**Vegetation Fuels:** Mixed conifer, sagebrush, and scrub oak. A large amount of the fuels in this area are either diseased or insect infested.

**Construction Materials:** All of the homes in this area are wood frame type construction.

**Roof:** Roofing material in the subdivision varies from wood shake to metal.

**Decks:** A majority of the homes in this area have unprotected wood decks.

**Special Hazards:** Above Ground electrical lines, unprotected wood decks, homes built on ridge tops, in chimneys and chutes one way in and out of subdivisions, no defensible space.

**Average Hazard Rating: High** (access, slope, no defensible space, building materials, water availability, fire history)

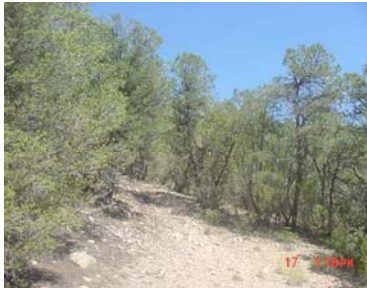
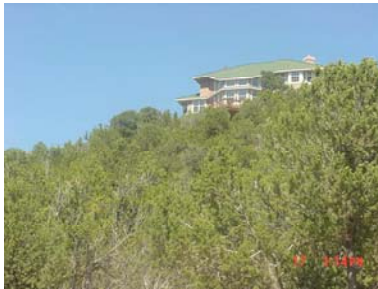
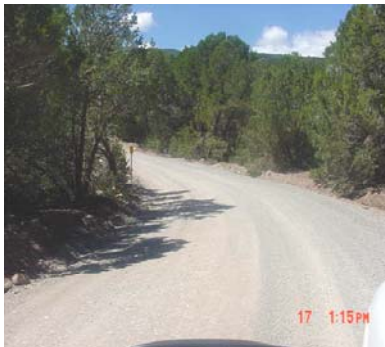
**Vegetation Fuels:** Mixed Conifer, sagebrush, and scrub oak. A large amount of the fuels in this area are either diseased or insect infested.

**Construction Materials:** All of the homes in this area are wood frame type construction.

**Roof:** Roofing material in this area varies from wood shake to metal.

**Decks:** A majority of the homes in this area have unprotected wood decks.

**Special Hazards:** above ground utilities, Wilderness area to the west

**Average Hazard Rating: High** (access, slope, no defensible space, building materials, water availability, fire history)

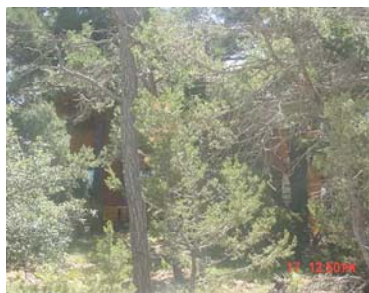
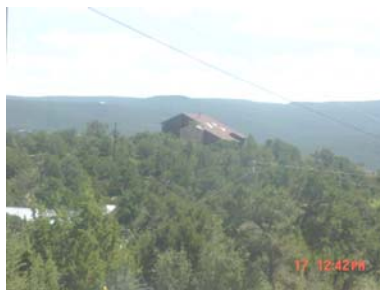
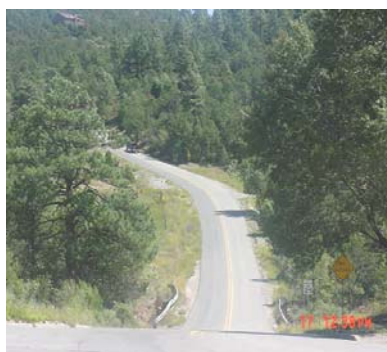
**Vegetation Fuels:** Mixed Conifer, sagebrush, and scrub oak. A large amount of the fuels in this area are either diseased or insect infested.

**Construction Materials:** All of the homes in this area are wood frame type construction.

**Roof:** Roofing material in this area varies from wood shake to metal.

**Decks:** A majority of the homes in this area have unprotected wood decks.

**Special Hazards:** Above Ground electrical lines, unprotected wood decks, homes built on ridge tops, in chimneys and chutes one way in and out of subdivisions, no defensible space.

**Average Hazard Rating: High** (access, slope, no defensible space, building materials, water availability, fire history)

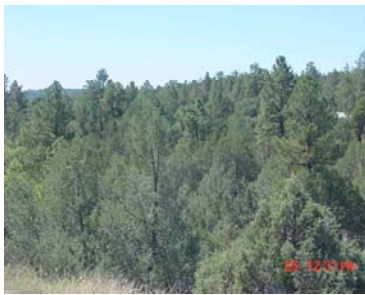
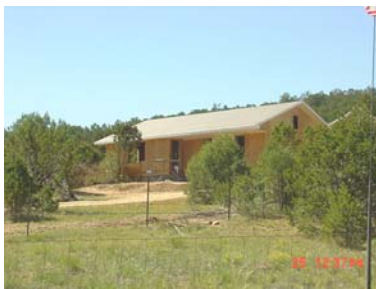
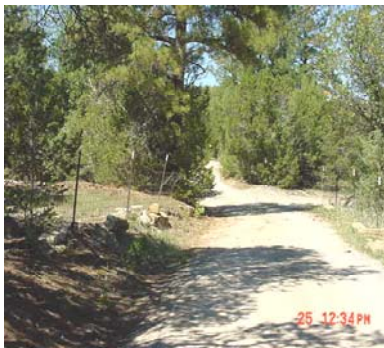
**Vegetation Fuels:** The fuels in this area are typical of the lower elevation, which consist of pinyon-juniper, grasses, sagebrush, and scrub oak. There are small stands of ponderosa pine and mixed conifer in this area as well. The fuels in this area are drought stricken, diseased, or insect infested.

**Construction Materials:** Wood frame/adobe

**Roof:** Mostly asphalt shingles a few with wood shake

**Decks:** A majority of the homes in this area have unprotected wood decks.

**Special Hazards:** Above Ground electrical lines, narrow winding roads. No defensible space, house built mid-slope, at the top of slopes, in chimneys, and in chutes. Long turn around time for water tenders.

**Average Hazard Rating: High** (access, slope, no defensible space, building materials, water availability, fire history)

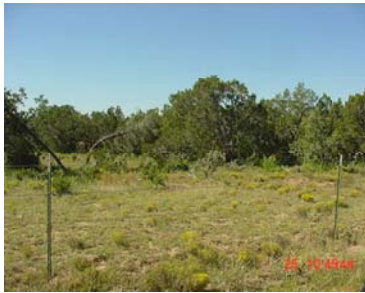
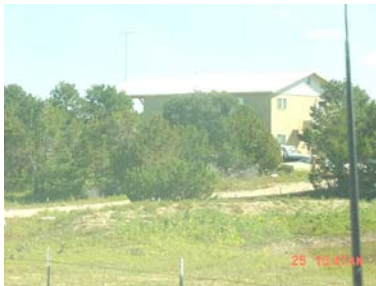
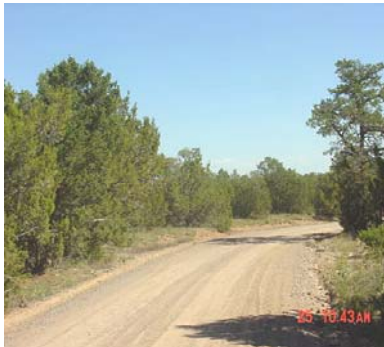
**Vegetation Fuels:** The fuels in this area are typical of the lower elevation conifers, which consist of pinyon-juniper, grasses, sagebrush, mixed conifers transitioning to ponderosa pine at the higher elevations. A lot of the fuels in this area are drought stricken, or insect infested, or diseased.

**Construction Materials:** The building construction varies from adobe to wood frame.

**Roof:** Mostly asphalt shingles a few with wood shake

**Decks:** A majority of the homes in this area have unprotected wood decks.

**Special Hazards:** Above Ground electrical lines, narrow winding roads. No defensible space, house built mid-slope, at the top of slopes, in chimneys, and in chutes. Long turn around time for water tenders.

**Average Hazard Rating: High** (access, slope, no defensible space, building materials, water availability, fire history)

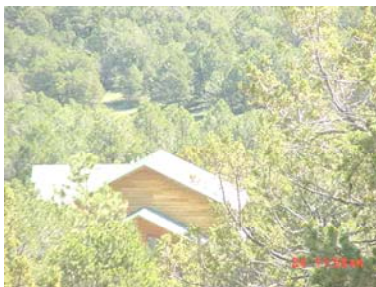
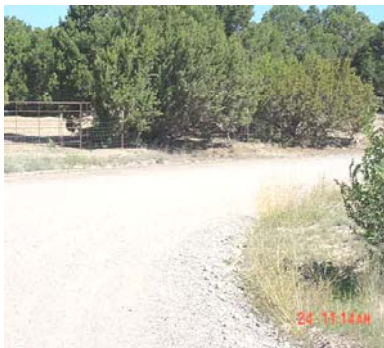
**Construction Materials:** Wood frame.

**Roof:** Mostly asphalt shingles a few with wood shake

**Decks:** A majority of the homes in this area have unprotected wood decks.

**Special Hazards:** Above Ground electrical lines, narrow winding roads. No defensible space, house built mid-slope, at the top of slopes, in chimneys, and in chutes. Long turn around time for water tenders.

**Average Hazard Rating: High** (access, slope, no defensible space, building materials, water availability, fire history)

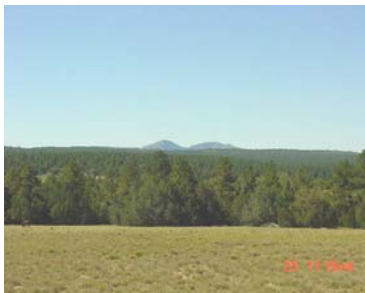
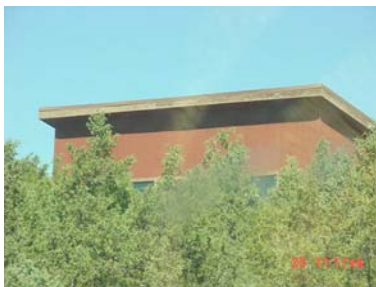
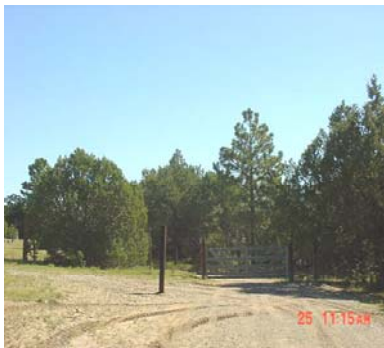
**Vegetation Fuels:** The fuels in this area are typical of the lower elevation, which consist of pinyon-juniper, grasses, sagebrush, and scrub oak transitioning to ponderosa pine and mixed conifer at the higher elevations. The fuels in this area are drought stricken, diseased, or insect infested.

**Construction Materials:** Wood frame/adobe

**Roof:** Mostly asphalt shingles a few with wood shake

**Decks:** A majority of the homes in this area have unprotected wood decks.

**Special Hazards:** Above Ground electrical lines, narrow winding roads. No defensible space, house built mid-slope, at the top of slopes, in chimneys, and in chutes. Long turn around time for water tenders.

**Average Hazard Rating:** High (access, slope, no defensible space, water availability, fire history)

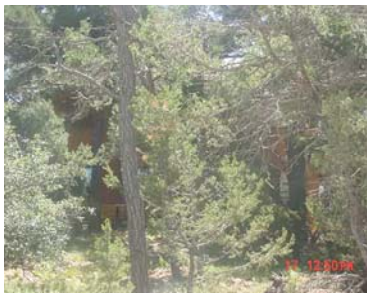
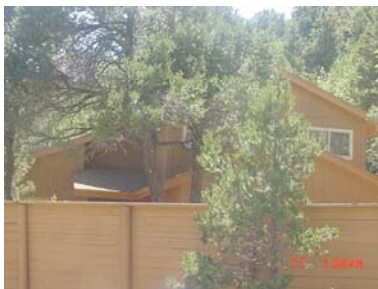
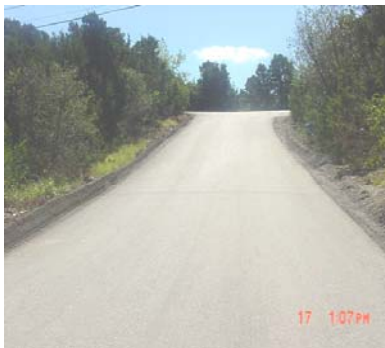
**Vegetation Fuels:** Mixed Conifer, sagebrush, and scrub oak. A large amount of the fuels in this area are either diseased or insect infested.

**Construction Materials:** All of the homes in this area are wood frame type construction.

**Roof:** Roofing material in this area varies from wood shake to metal.

**Decks:** A majority of the homes in this area have unprotected wood decks.

**Special Hazards:** All utilities are under ground.

**Average Hazard Rating: High** (access, slope, no defensible space, building materials, water availability, fire history)

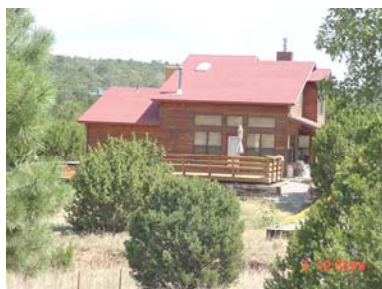
**Construction Materials:** All of the homes in this area are wood frame type construction.

**Roof:** Roofing material in this area varies from wood shake to metal.

**Siding:** Most of the homes are stuccoed some of the homes have wood siding.

**Decks:** A majority of the homes in this area have unprotected wood decks.

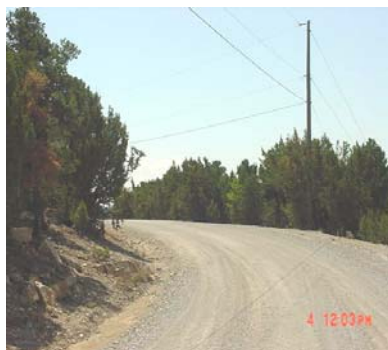
**Terrain:** Slope 20%-60% Aspect all

**Access:** The access to this area is a two-lane paved rd (La Madera Rd.), which is the only way in and out of the area

**Special Hazards:** above ground utilities, unprotected propane tanks, no defensible space, prolonged response time.

**Average Hazard Rating: High** (access, slope, no defensible space, building materials, water availability, fire history)

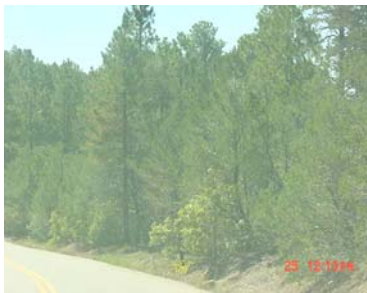
**Descriptive Location:** This area is off of Hwy 222. This area has numerous roads that are dead-ends and are not marked as such. Houses in this are built on ridge tops, mid-slope, in chimneys, and chutes.

**Vegetation Fuels:** The fuels in this area are typical of the lower elevation conifers, which consist of pinyon-juniper, grasses, sagebrush, mixed conifers transitioning to ponderosa pine at the higher elevations. A lot of the fuels in this area are drought stricken, or insect infested, or diseased.

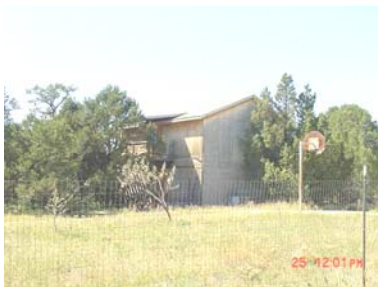
**Construction Materials:** Wood frame type construction

**Roof:** Varies from wood shake to metal

**Siding:** Mostly stucco, several homes have wood siding

**Decks:** A majority of the homes in this area have unprotected wood decks.

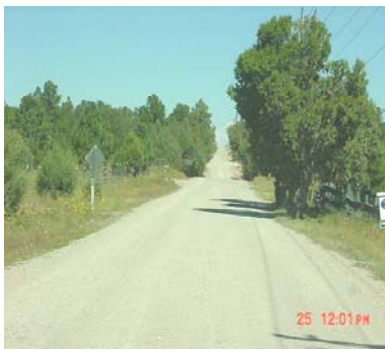
**Terrain:** Slope 5%-45% Aspect all

**Access:** The main access to this area is Prima Agua Rd., which is off of Hwy 66.

**Special Hazards:** Above Ground electrical lines, narrow winding roads. No defensible space, house built mid-slope, at the top of slopes, in chimneys, and in chutes. Exposed propane tanks

**Average Hazard Rating: High** (access, slope, no defensible space, building materials, water availability, fire history)

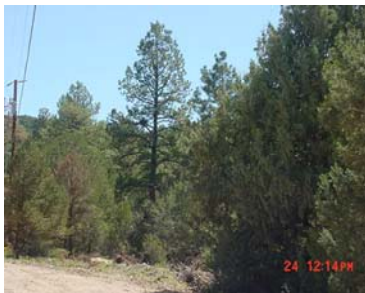
**Descriptive Location:** This area is off of Hwy 66 in Tijeras. There are three different subdivisions in this area. One of the subdivisions has roads throughout that are very confusing. Once inside the subdivision there is no clear path of egress. There is one subdivision that is behind a locked gate that can be actuated by using the yelp on a siren.

**Vegetation Fuels:** The fuels in this area are typical of the lower elevation conifers, which consist of pinyon-juniper, grasses, sagebrush, mixed conifers transitioning to ponderosa pine at the higher elevations

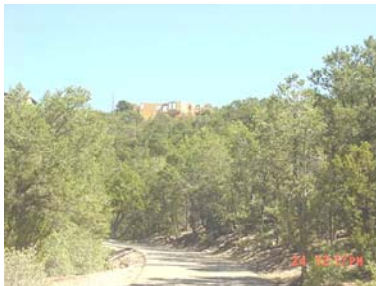
**Construction Materials:** Wood frame type construction

**Roof:** Mostly asphalt shingles a few with wood shake

**Siding:** Mostly stucco, several homes have wood siding

**Decks:** A majority of the homes in this area have unprotected wood decks.

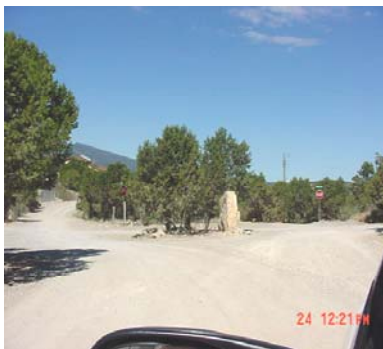
**Terrain:** Slope 5%-45% Aspect all

**Access:** The main access to this area are various roads off Hwy 66 and Zamora Rd (North and South)

**Special Hazards:** Above Ground electrical lines, narrow winding roads. No defensible space, house built mid-slope, at the top of slopes, in chimneys, and in chutes.

**Average Hazard Rating: High** (access, slope, no defensible space, building materials, water availability, fire history)
